# UV Degradation of Polychloroprene Used in Waterski Boot Bindings

J. Fiedler, L. LaCasse, C. M. Liu, M. Muñoz, K. Reader  
Department of Materials Science and Engineering, University of Michigan, Ann Arbor, MI

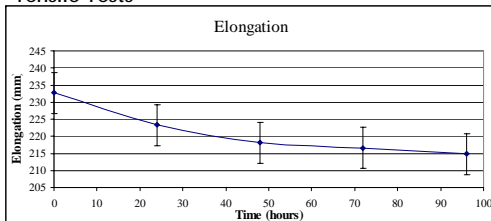
Figure 5: Elongation of samples with increasing duration of UV radiation.

Figures 5 and 6 show results from testing tensile bars exposed to UV radiation at 350 nm for different lengths of time. As shown in Figure 5, the elongation of the tensile bars decreased significantly with increasing duration of UV radiation. A similar trend is seen in Figure 6, where the tensile strength of polychloroprene specimens decreases with increasing radiation. An  $R^2$  value of approximately 0.93 indicates that this degradation of tensile strength is linear. The degradation of tensile properties that is exhibited in Figures 5 and 6 is due to the increased cross-linking induced by UV radiation. As more cross-links form, the bonds between highly cross-linked sections become weakened and cause potential locations for failure. Therefore, increasing UV exposure causes additional cross-linking to occur and weakens the material in tension.

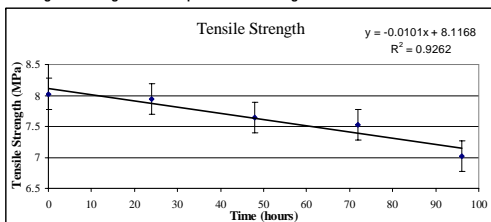
Figure 6: Tensile strength of samples with increasing duration of UV radiation.

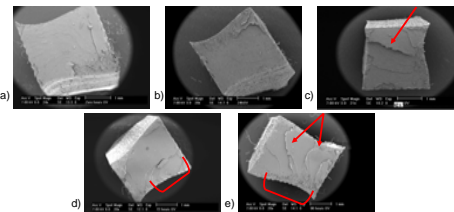
Figure 7 shows samples which were unexposed to UV radiation and 24 hours of radiation have smooth fracture surfaces in comparison to those which were exposed to 48, 72, and 96 hours of radiation. Differences are likely due to the degradation of the elastomer. The UV light excites bonds in the material, inducing the polychloroprene to form additional cross-linking bonds, causing the material to become more brittle. With increasing UV exposure (and increasing cross-linking), more crazing is seen from tensile testing. This is indicated in Figure 7d and 7e by red brackets. Each bump shows a section that has been cross-linked. The bonds between these highly cross-linked bumps are relatively weak, so they serve as points of failure. As failure propagates from each point, a plane is formed on the surface of the material. With more crazing points on different planes, the ridges that are indicated in Figure 7 by red arrows are formed.

Figure 7: SEM images of the tensile fracture surfaces of the polychloroprene samples after UV radiation for a) 0 hrs, b) 24 hrs, c) 48 hrs, d) 72 hrs and e) 96 hrs.
